Analysis of a possible root cause and mechanism for Soma mine disaster

B. Ünver* and M.S. Ünal

Department of Mining Engineering, Hacettepe University, Ankara, Turkey

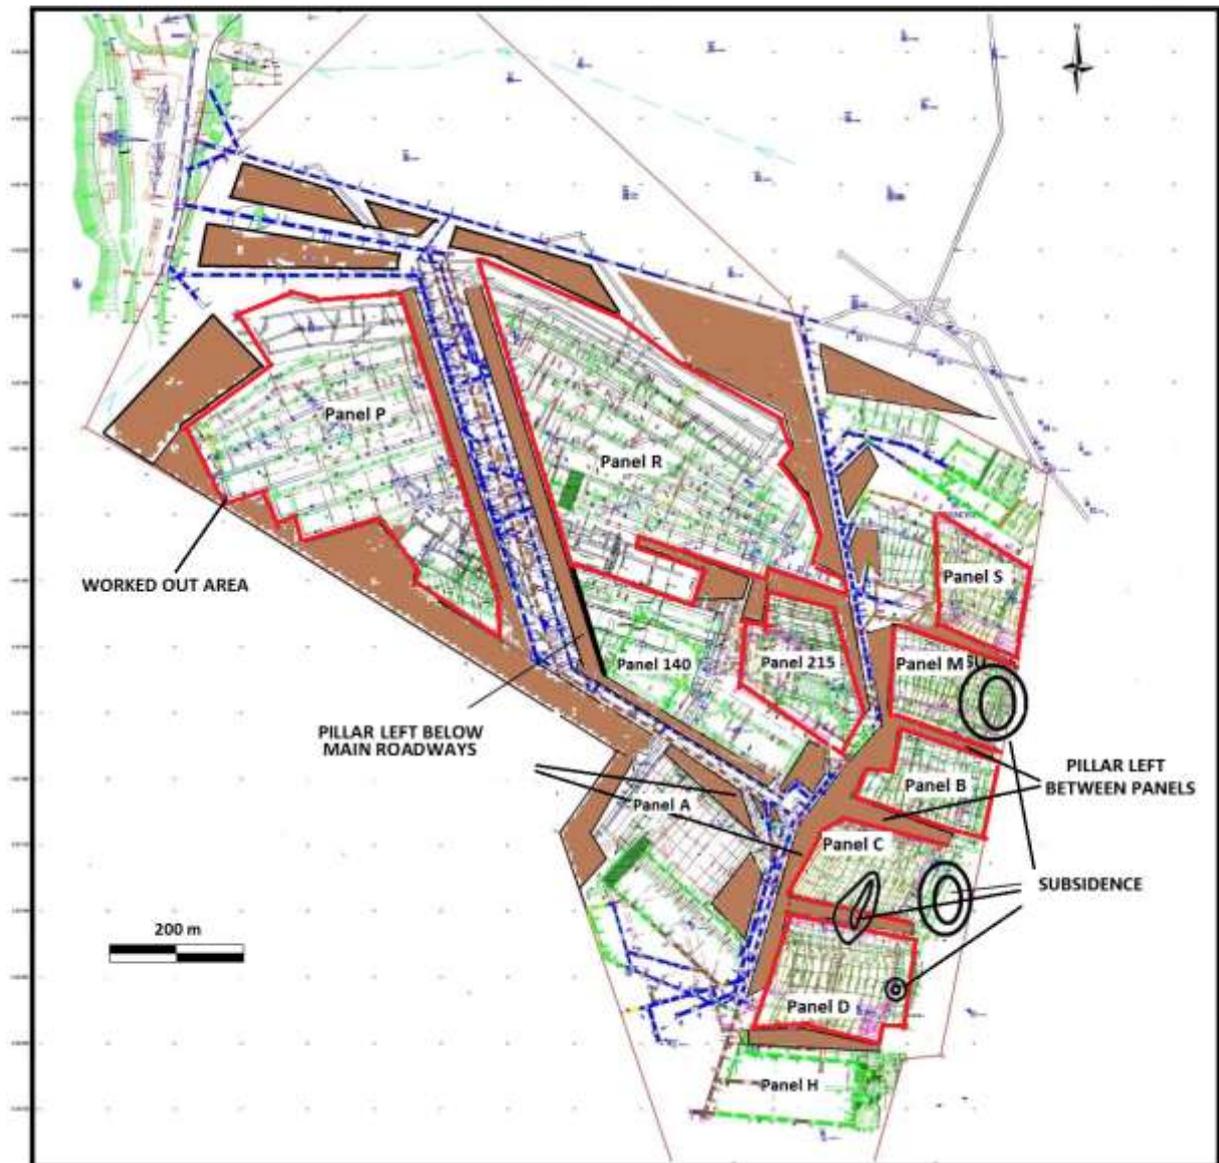
Figure 6. Mine plan showing old and active production areas, protective pillars, and locations of excessive subsidence observed at the surface (modified from [8]).

Unfortunately, no systematic subsidence measurement had been carried out during production at the Karanlıkdere mine. Only locations of excessive subsidence and sinkhole formations were drawn on plans. These features could even be seen at google earth images, as shown in Figure 10. There is a large sinkhole formation at the surface at panel M and fault contact (Figure 12). Even this area was filled and leveled; indications could still clearly be seen on the surface. There must be a sinkhole formation also over panel B. Although some indications of subsidence at panel B fault contact can be seen on google earth image, it cannot clearly be pointed out due to the waste flowing from open-pit overburden dump area.

➤ Roof caving mechanism and its relation with subsidence must be fully determined and continuously monitored. Geophysical techniques can be used to point out any void over-production areas. Progress of roof caving and its behavior and stability conditions in mine should be continuously monitored by the 3D passive seismic method.

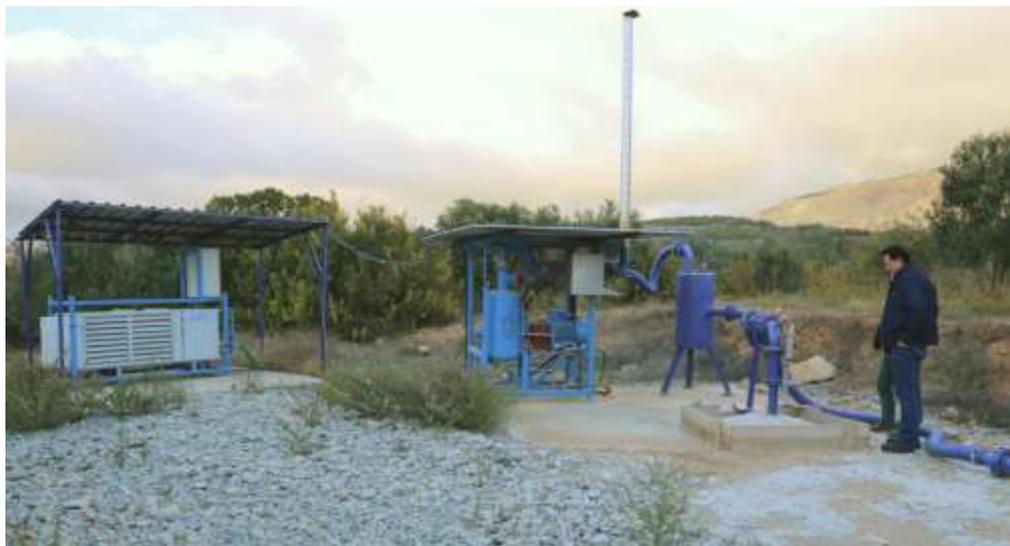
Figure 7. Methane drainage borehole and facility above Panel A.

There are two operating faces at panel A, namely A2 mechanized and A2 semi-mechanized. The production activity was carried out between +95 and +86 levels at panel A. Dip of seam in this area was around 7°. Production started at Panel A in 2009 by the previous contractor. A coal face was formed at the roof of the seam. For the first time in Eynez, a significant amount of methane emission was observed since elevation of Panel A was the deepest level reached so far. Therefore, production was halted, and Park assigned the mine to the present company, Soma Coal, with the permission of TKI. Then a project was put forward to apply methane drainage in Panel A including opening of a surface borehole, where methane was sucked for drainage purpose (Figure 7).

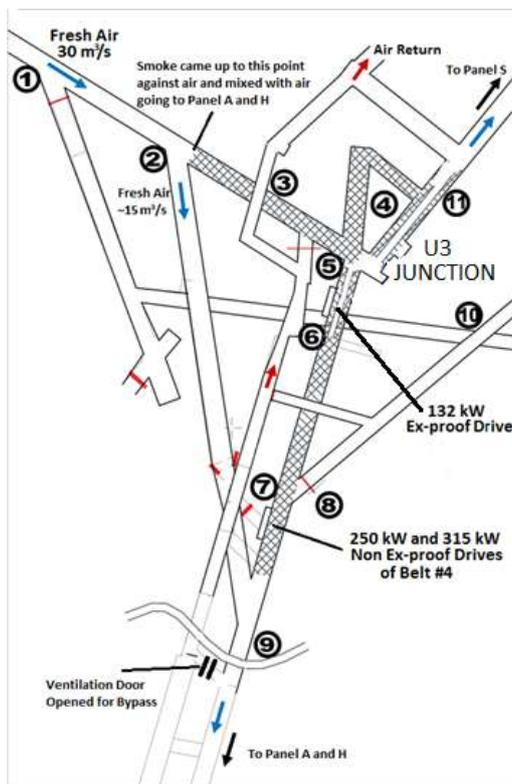
Figure 8. A close-up plan of mine fire start region (modified from [8]).

Numbers on the plan are put intentionally for reference purposes in order to explain the area. The roadway at point #1 is connected to fresh air intake. Point #2 is the junction; turning right towards south is the way to panels A and H, and the straight direction is to the U3 junction. The incline having a low slope between point #2 and point #9 was opened for transportation of mechanized face equipment to panel A. Although it was possible to reach the same point by following the way from points #2, #5, and #9, there was a cross-section constraint due to existence of belt conveyor on the way and closure of the roadway due to deformations. The roadway from point #1 towards right was used for an old working in panel A. It was closed and secured by means of a dam, and all the old working area was said to be hydraulic fly ash filled. As clearly seen in the plan, U3 junction was located at the hearth of mine. Roadway from point #5 towards point #11 was the way to panel S, where the most of casualties (272) have taken place. The opening around point #4 was the main transformer station. Roadways shown with point #8 and point #10 were used during production of panels C and D. They were closed; dams were constructed, and the old working area was backfilled with hydraulic fly ash.

Fresh air having a quantity of 30 m³/sec feeding the whole mine comes from point #1 towards point #2. The fresh air was almost halved in two branches; one going towards south for ventilation of the panels A and H and straight towards U3 junction and going towards north for ventilation of panel S. The section between point #5 and point #9 was not well-ventilated, and there was a very slow air flow towards point #9 to point #5. Since this location was not well-ventilated and there were drive motors of the belt conveyor #4, the passage was disturbingly hot, and it was almost never used for a passage way between point #5 and point #9 by the personnel.

Witness statements undoubtedly reveal that the cause of mine fire cannot be due to spontaneous combustion of coal. As a matter of fact, there is no coal cut in the roadway between point #5 and point #9. During our visit to mine with the members of parliament, we were able to see the mine fire start location.

- A crew of workers working between points #3 and #5 claim that a boulder size rock has fallen from the roof, touching slightly the shoulder of one of them. They realized that a grey-blackish smoke was coming through the fractures in the rock at the roof from the place where the boulder was fallen. Then smoke from point #5 towards point #3 started to come in an increasing manner.

- During fire fighting efforts after 2 days of fire start, a strong flame at point #1 in front of the dam constructed for isolation of an old production area shown in Figure 8 was observed. The engineers and workers claimed that this was definitely a different flame in comparison with other locations as if a gas coming above the dam thorough cracks was burning. It was also stated that although the fire at other locations could easily be put out, this flame could not be extinguished.

- There was no intersection of coal observed along the whole roadway between point #5 and point #7. Fire start location was completely in rock. However, the hydraulic ash filled area could not be seen.

- From point #5 towards #11, wooden lagging at the roof was burnt out; however, there was not a clear sign of burning at the side-walls. This is an indication that fire was in the form of a flame at the roof, not at the sides.

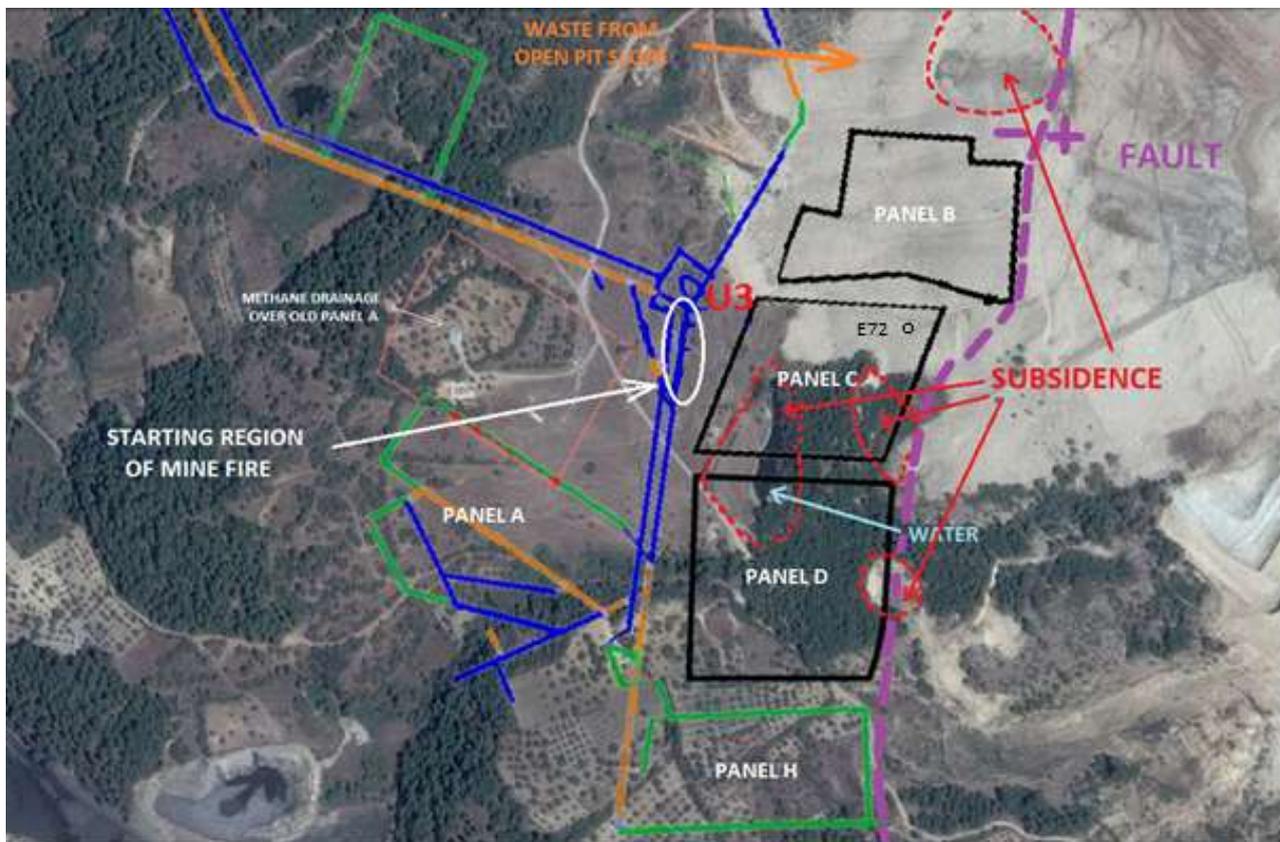
Figure 10. Details of mine plan on satellite image.

Figure 10 presents the mine plan on satellite image, showing the important features that are of significance importance to understand the root cause and mechanism of the mine fire. It is for sure that by means of witness' statements and

sensor readings, everything was as usual in the vicinity of mine fire start location right before the mine fire had started. There is no doubt about the mine fire start location. Experience of smoke was almost instant. At first, the smoke was white-yellow, and then it turned out to be a thick black smoke. Although the passage between point

#5 and point #9 where the belt #4 drive head was installed was not frequently used by workers for walking through, both ends were walked by hundreds of workers every shift and the mine fire was started in a roadway opened completely in rock. Therefore, the cause of fire cannot possibly be due to classical spontaneous combustion.

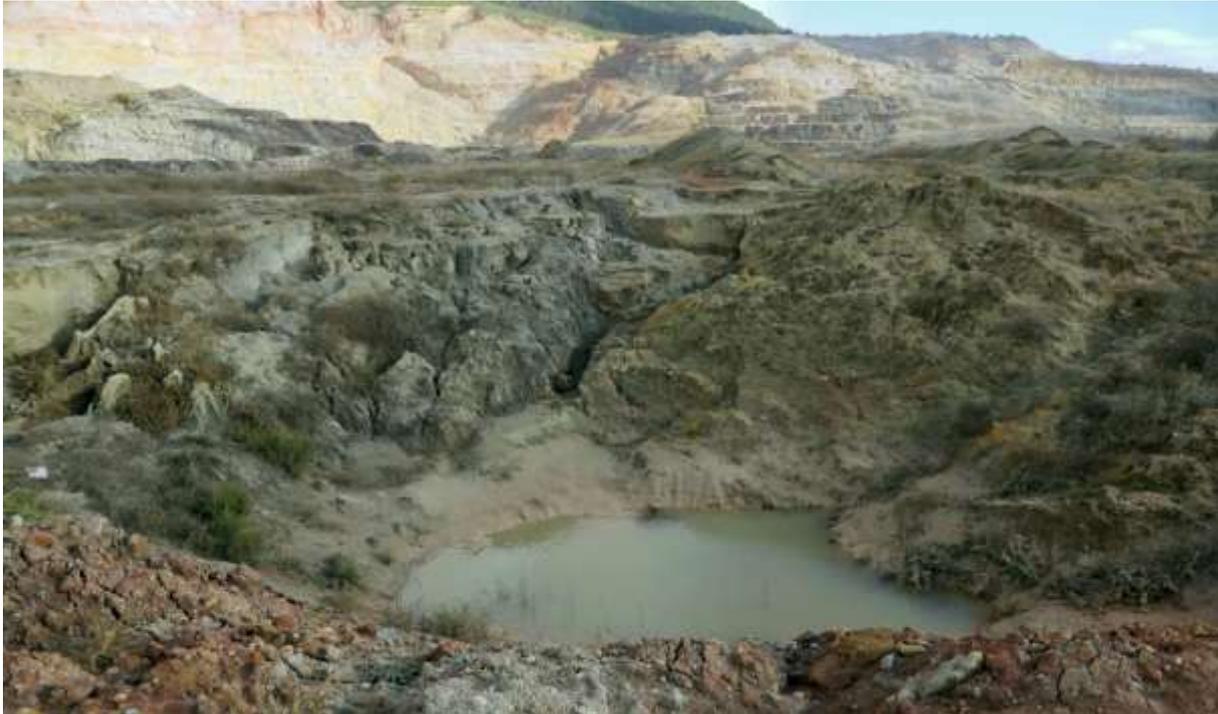
Figure 12. Subsidence sinkhole over panel M.

Relationship between the subsidence and sinkhole formations on the surface above panel C and panel D is rather important in understanding the mechanism of roof caving during production at these panels. At the fault contact of both panels, subsidence sinkholes were formed, as shown in Figures 10, 12, and 13.

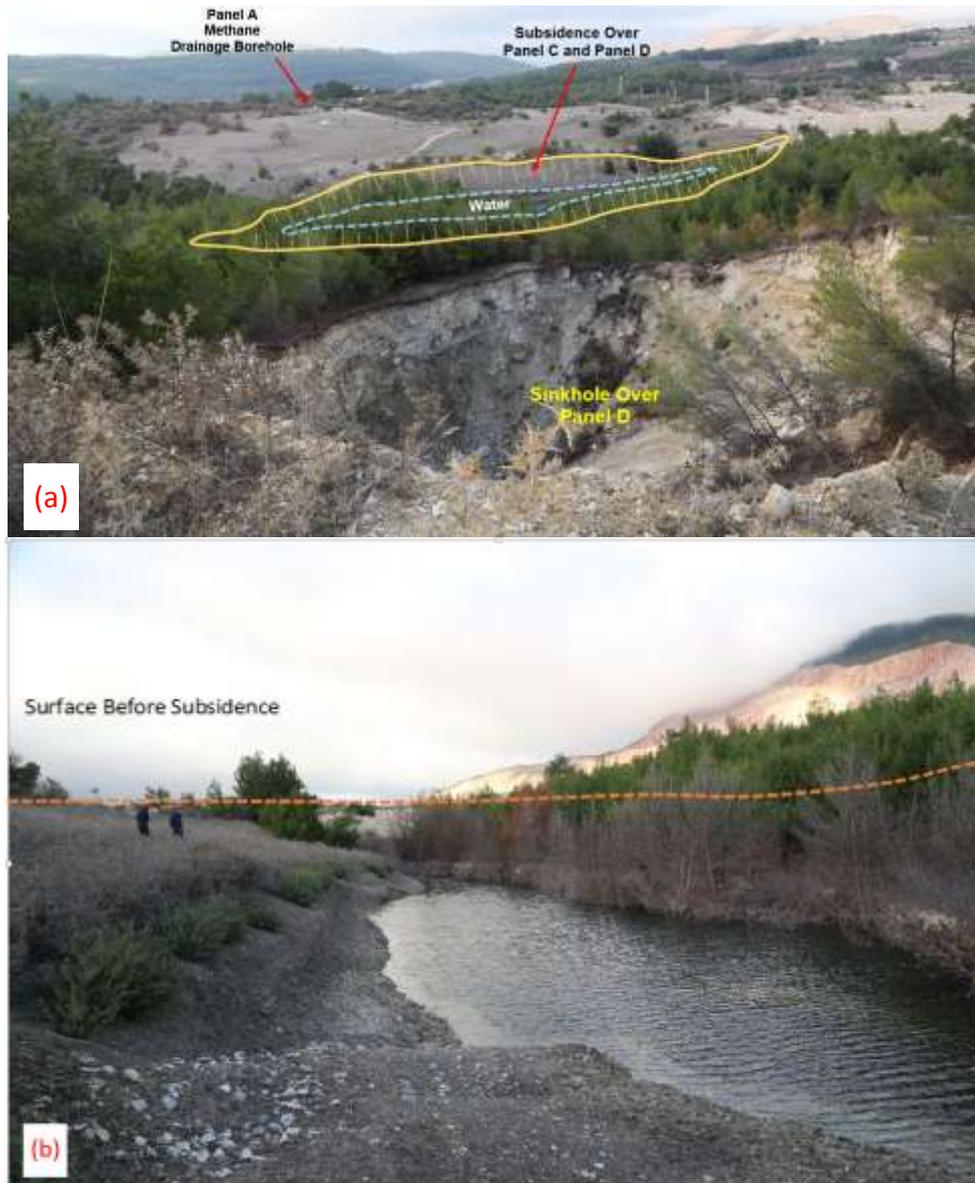
Figure 13. a) Sinkhole over panel D fault contact, and b) water filled subsidence wedge formation across panel D and panel C.

formation of subsidence at the surface, there must be voids in the form of triangles created as a result of bed separation above the production areas. As the goaf was not loaded properly due to bed separation and formation of voids, consolidation of caved rock would not have been effectively taken place. Hence, unconsolidated goaf can have a lot of empty space for light methane to fill in.

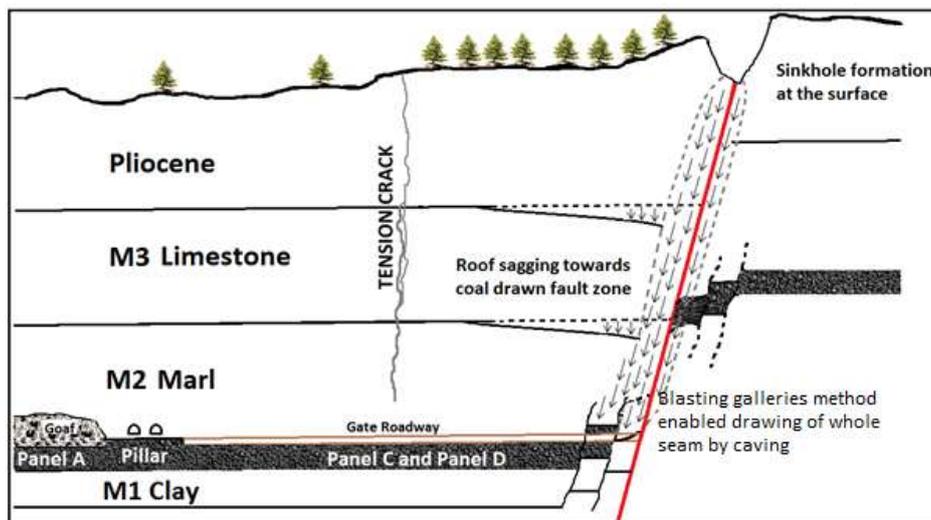
the western side, and the support was lost on the eastern side, i.e. parallel to the fault plane. The beam must be broken at a certain distance parallel to the face and fault plane. Hence, a tension crack must be formed across panel C and panel D. This crack exactly coincides with the water filled wedge observed at the surface (Figure 13). The sinkhole formed over panel D, shown in Figure 13(a), was so deep that although it was filled with 1250 tons of truck load of rock, it was still very deep. Formation of a huge tension crack between panel C and panel D definitely affected the caving mechanism during the production of these panels. As the coal was produced in three slices in these panels, a huge crack formed perpendicular to the advance direction governed the caving. During production, the wedge-like subsidence was created as the wedge must have deepened during the subsequent productions of slices from top to bottom. This phenomenon is schematically shown on a drawing in Figure 14. Water accumulated in the wedge must have filled the possible escape ways of the accumulated methane inside the goaf. Apart from the sinkholes and subsidence along the fault line and the water logged wedge, no signs of further subsidence could be observed at the surface. When it was considered that around 25 m thick coal seam was produced, its indication on the surface was not visible apart from the features described above. This must be due to the strong and massive characteristics of the M2 marl and M3 limestone strata. In addition to this, the M3

a) Formation of sinkhole due to full stamp caving of coal at fault contact and formation of tension crack in the middle due to diminishing of constraint on roof strata at fault side.

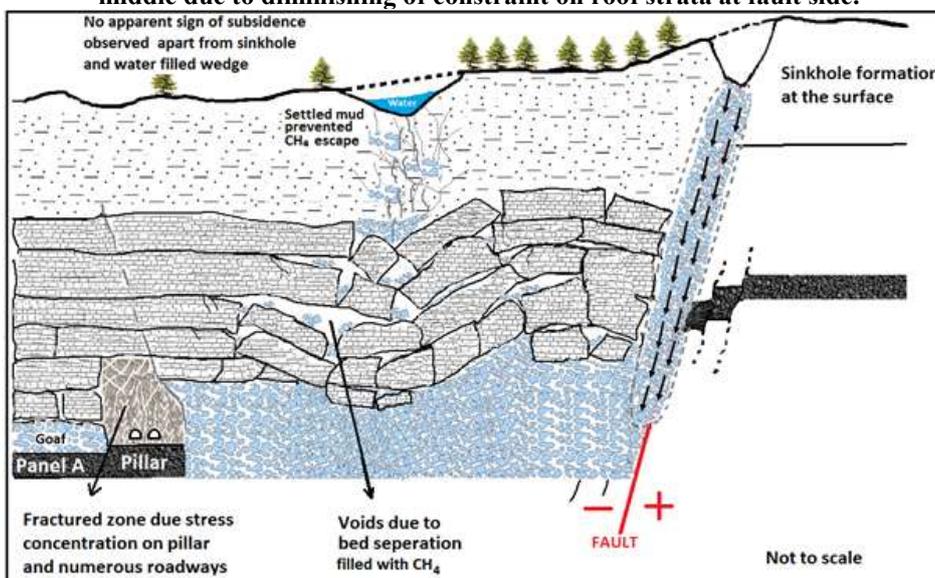
b) Caving of roof after production of three slices resulting in void formation filled with methane due to bed separation and unconsolidated goaf.

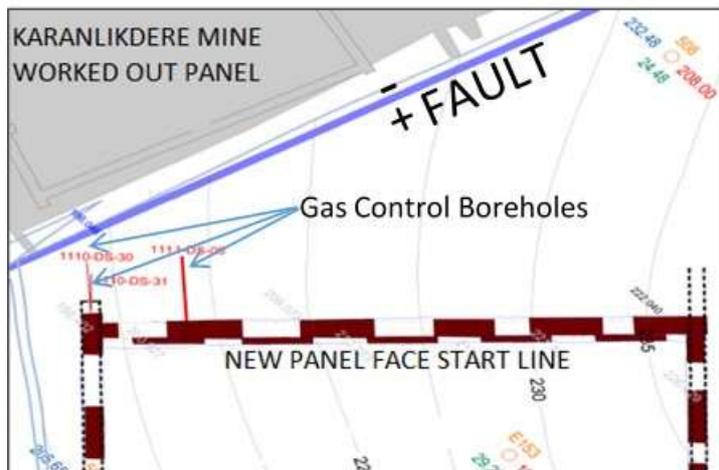
Figure 16. Locations of gas control boreholes opened towards old workings of Karanlıkdere mine.

Production was started at the adjacent mine in February 2015. Top slice production has been completed at the panel located in the middle, as shown in Figure 15. During development of the nearest panel to the old workings of Karanlıkdere mine, gas control boreholes were drilled, as seen in Figure 16.

As shown in Table 3, after drilling 24, 15, and 12 m, concentrations of CH₄ and CO₂ were found to be above the detection limits. Unfortunately, it was not possible to learn the exact gas concentrations. This can be considered as an indication of gas accumulation in the caved regions of the old workings of Karanlıkdere mine. It is probable that the caved regions of Karanlıkdere mine have been interconnected due to caving during production of the middle panel at the new adjacent mine. This might have resulted in the escape of some CH₄ to the surface through newly-formed subsidence cracks. It is also possible that a connection between these two mines might have been created, forming an air passage way between these mines. It is suggested that these phenomenon should be further investigated. It is also suggested to open methane drainage surface boreholes, especially above panel D and panel H of Karanlıkdere mine before commencing the production activity at the mine.
