A Preliminary Assessment of Rock Slope Stability in Tropical Climates: A Case Study at Lafarge Quarry, Perak, Malaysia

K.S. Shah, M.H. Mohd Hashim*, K.S. Ariffin and N.F. Nordin

Strategic Mineral Niche, School of Materials and Mineral Resources Engineering, Universiti Sains Malaysia, Penang, Malaysia

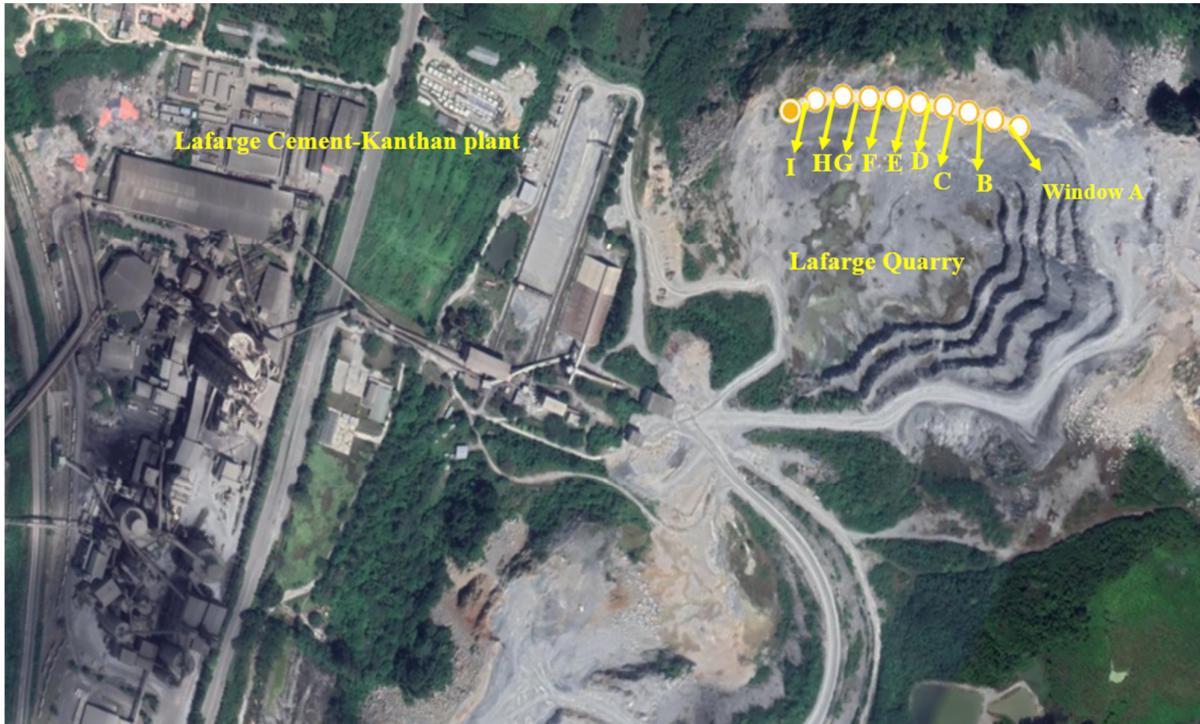
Figure 2. The map showing Lafarge quarry with all windows.

In this work, a cement quarry was selected to investigate the slope stability using two classification systems. Window mapping is a technique used by various researchers to record the geological information and the discontinuity characteristics at the rock slope face. The quarry is divided into ten windows at an interval of 30 m for each section (see Figure 2).

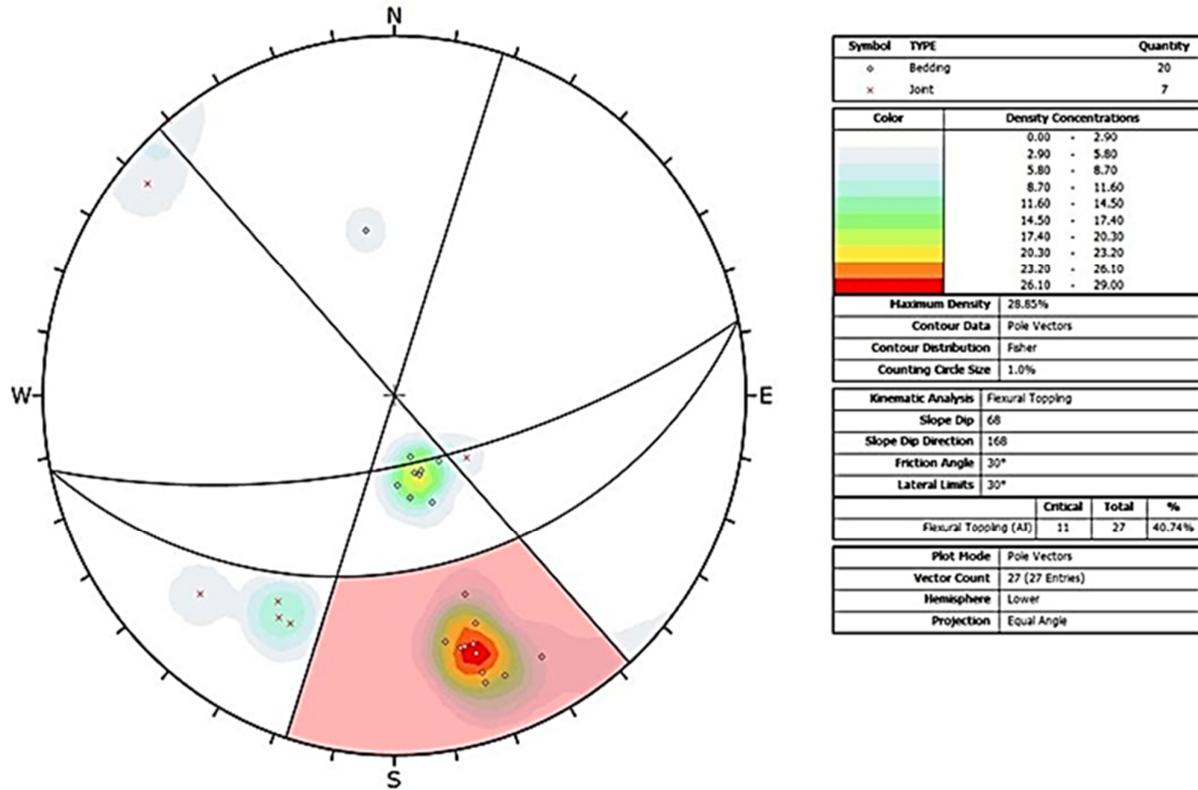
Figure 3. Flexural toppling failure for window A.

For window A, the density of high concentration was located at 160° near the south region. There were also present other concentrations in the same direction but with a different angle. The maximum

density in the contour was 28.85%. As discussed earlier, window A has a high tendency for the flexural toppling failure to happen. From the kinematic analysis of the flexural toppling failures, 11 sets of discontinuities from 27 lied in the critical zone for the flexural toppling failure to happen. That makes 40.74% of discontinuities lying in the critical zone and can be considered as critical (more than 30).

The planar and plane sliding failure modes for many rock slopes are generally in the order of 2.23–52.64%. The critical limit was recorded at 40.74% at window A (see Figure 3). The results obtained show that window A has a high tendency for toppling failure to occur. The tendency for the wedge sliding failure was also critical at window H. The critical limit for the wedge sliding mode

window showing the value inside that range. Window A had a high tendency for the flexural toppling sliding mode to happen with a value of 40.74%. Window H and window A are discussed due to the critical condition and tendency for failure to happen.

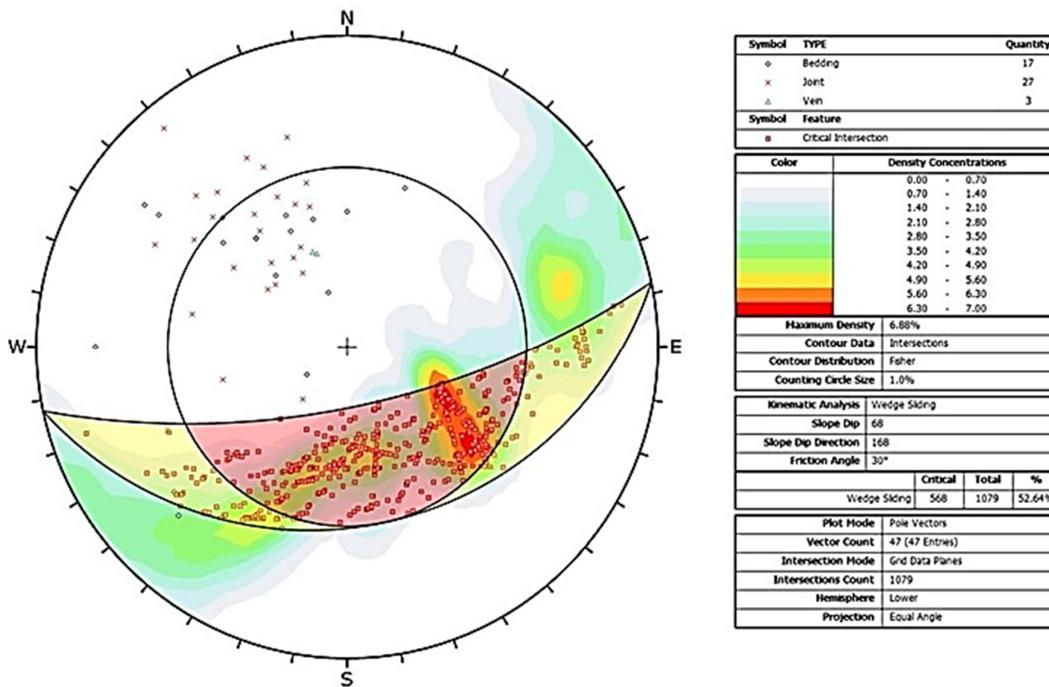
Figure 5. Stereographic projection showing the potential for wedge failure for window H.

From the wedge failure contour generation by the kinematic analysis, it was found that 568 of the total intersection lying in the critical zone was susceptible to wedge failure. As we know, wedge failure tends to happen when two discontinuities intersect with each other. From the contour generation, we know that there are 1079 of the intersection of discontinuities present. However, only 52.64% of them lied in the critical zone with

tendency for the wedge failure to happen (see Figure 5). From the contour, 52.64% (more than 30%) could be considered as the critical condition. Window H is required to be inspected regularly because the tendency for the failure to happen is high. The presence of the wet surface conditions (reduced rock mass shear strength, which is susceptible to deteriorate due to the moisture content) may increase the critical level of failure.

recorded by window H was 52.64% (see Figure5) and the plane sliding recorded for window H is 42.55% (see Figure 4). Other windows could be considered as less critical (less than 30%) except for window G, which was located at the side of window H with a tendency of 34.03% for the wedge sliding mode to occur.

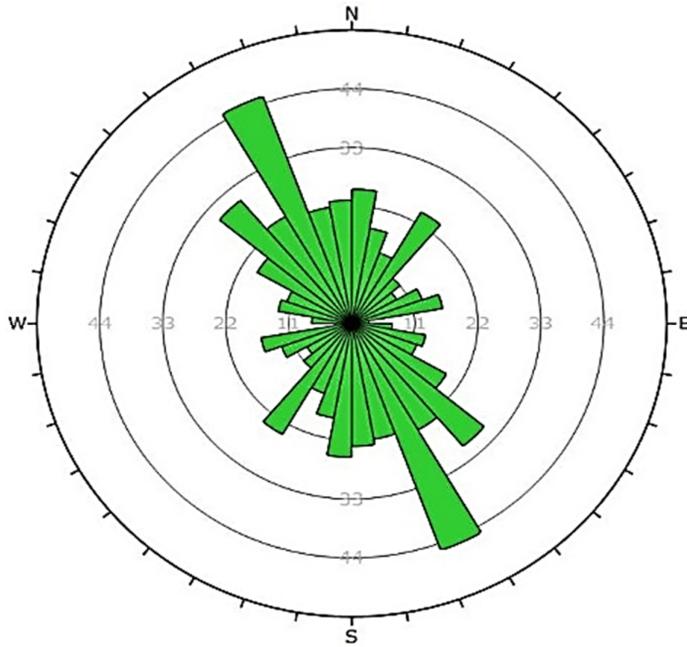
Figure 6. Rose diagram for all windows showing the discontinuity directions.

The overall window is the overall data that represents the whole slope being studied, and this means that all the data from all windows is being entered to create the contour of stereonet and rose diagram. From the rose diagram for the overall window (see Figure 6), we could see that the direction of the discontinuities for the overall slope dominantly was at 150-160° in direction. This

could happen due to the presence or appearance of joint sets in the same direction. The highest concentration of the discontinuities was located at 230–250° near the southwest region. Two contours could be seen in the west region. It can be caused by the same discontinuity location but slightly different in the dip reading.

Plot Mode	Rosette
Plot Data	Apparent Strike
Face Normal Trend	0.0
Face Normal Plunge	90.0
Bin Size	10°
Outer Circle	55 planes per arc
Planes Plotted	327
Minimum Angle To Plot	45.0°
Maximum Angle To Plot	90.0°

Nevertheless, the concentration was a little low compared with the first concentration mentioned before. The maximum density of concentration present was 5.71%. A total of 180 sets of bedding and 229 sets of joints were recorded. There were also present 8 sets of calcite veins and 6 sets of faults that made the total data being recorded as 423 sets of discontinuities.

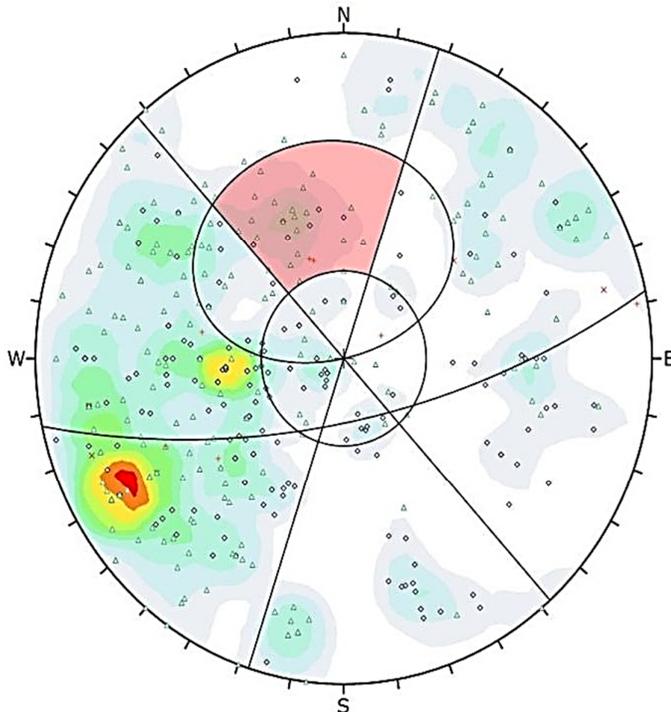
Figure 7. Planer sliding failure for overall windows.

For a failures mode, we go through the planar sliding failure first. For a planar sliding failure (see Figure 7), from the contour generation by the kinematic analysis, it was found that a total of 30 sets (7.09%) of discontinuities occurred within the critical zone susceptible to the planar sliding failure.

Kinematic Analysis	Planar Sliding
Slope Dip	68
Slope Dip Direction	168
Friction Angle	30°
Lateral Limits	30°

Critical	Total	%
Planar Sliding (All)	30	423	7.09%

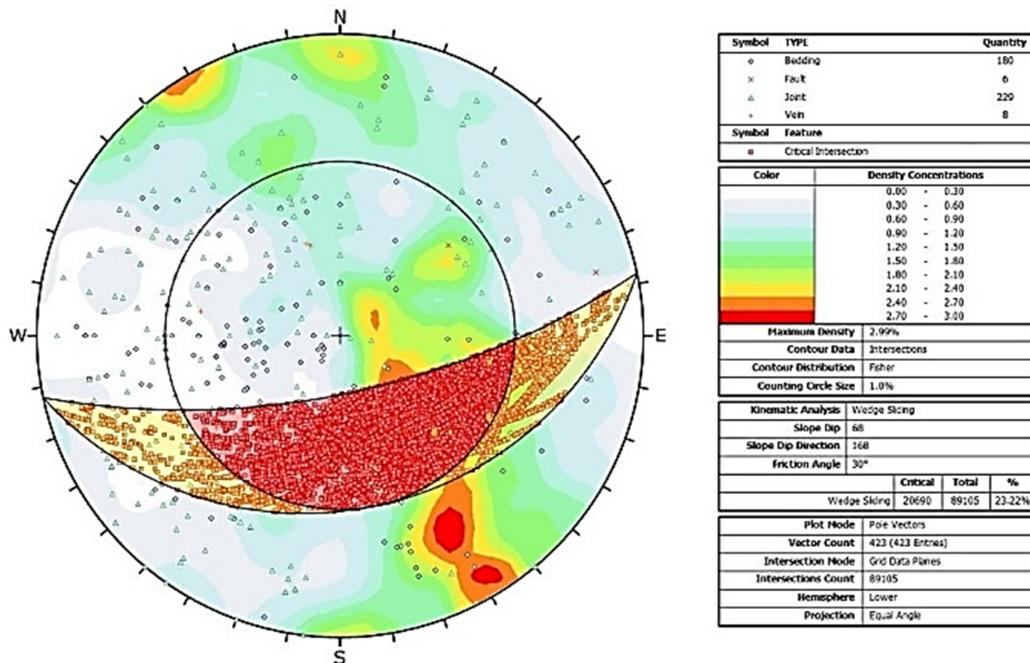
Figure 8. Wedge sliding failure for overall windows.

From the wedge failure contour (see Figure 8) generation by the kinematic analysis, 20690 of the intersection was present in the critical zone for the wedge failure to happen. Notably, the wedge failure tends to happen when two discontinuities intersect with each other. From the contour generation, we know that there are 89105 of the intersection of discontinuities present. However, only 23.22% of them are located in the critical zone that tend for the wedge failure to happen. From the contour, 23.22% (< 30%) can be considered as a less critical condition. However, the presence of wet surface conditions (i.e. reduced rock mass

shear strength, which is prone to deteriorate as a result of moisture content) may increase the critical level of failure.

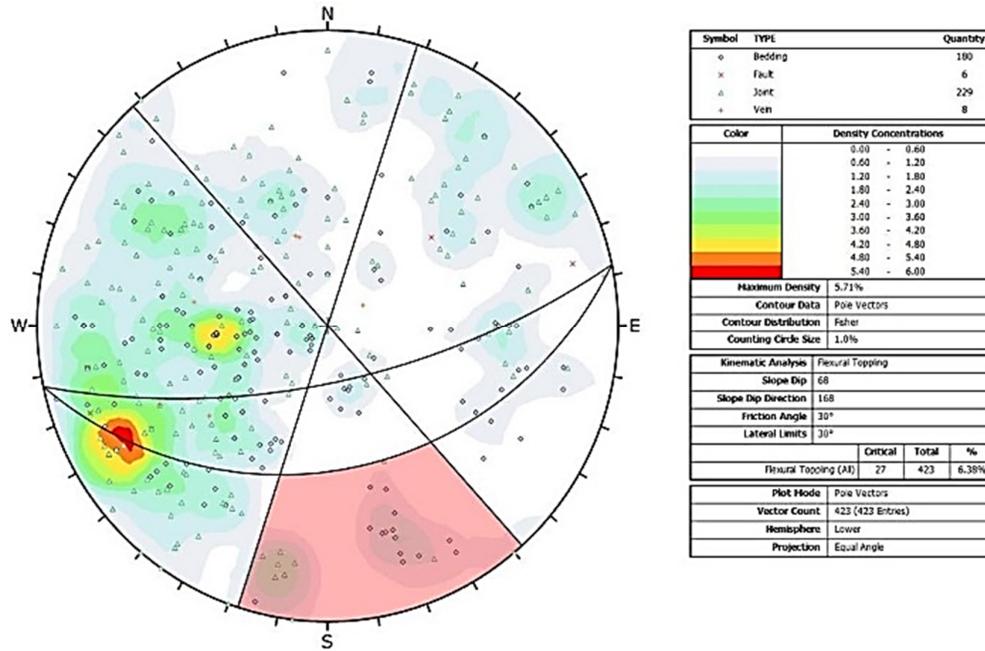
Figure 9. Flexural toppling failure mode for overall windows.

Lastly, the kinematic analysis of the flexural toppling failures (see Figure 9) was generated by the software. 27 sets of discontinuities lied in the critical zone, being susceptible to the flexural toppling failure. That makes 6.38% of discontinuities lying in the critical zone. The requisite for flexural toppling failure to occur, a plane is required with a dip less than the friction angle of that plane or any infilling material that may be present and a dip direction out of the slope.

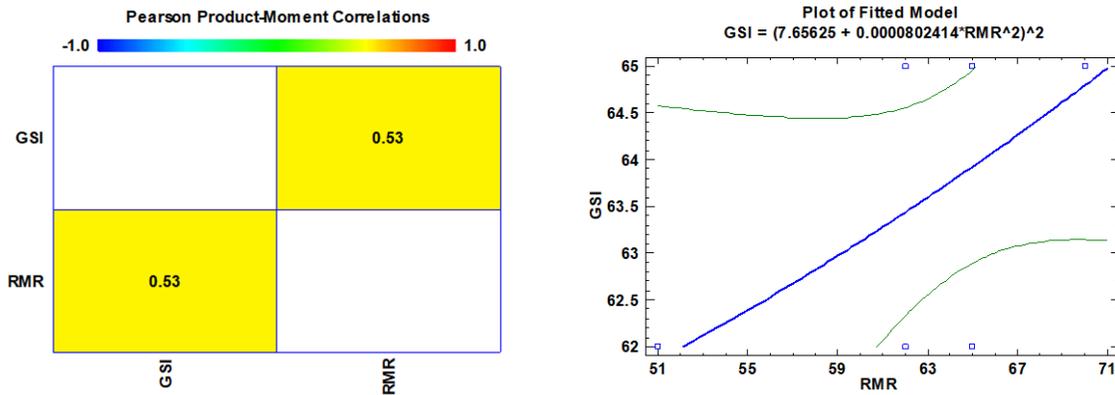
Figure 10. Correlation and regression between and RMR and GSI.

due to the quarry containing the rocks with fair to good quality. The Kanthan quarry slope was divided into 10 windows, and was studied using the RMR and GSI systems. The RMR values in this research work ranged from 62 to 70, and the GSI values ranged from 62 to 65. RMR and GSI had a good positive correlation (shown in Figure 9), revealing that RMR increased with an increase in GSI. However, for a soft rock, the RMR and GSI values tend to reduce, while it increases for the hard and massive rocks. The regression model for RMR and GSI are presented in Figure 9. The regression model was trained using the data collected from the RMR and GSI classification systems, and the optimal equation obtained for the prediction of GSI was given in Figure 10.

The RMR analysis obtained from each window showed that all windows, except for window D, could be classified into good rock, and window D was classified as fair rock. The RMR rating for window D was different due to the presence of water seepage at the slope face. As for the GSI classification scheme, the GSI value depends on the structure and surface condition of the discontinuities. The GSI value for each window was almost the same with only a slight difference in the range of 55-70. The GSI classification scheme requires much experience to make a precise judgment in the evaluation. Besides, the RMR classification scheme depends on six parameters compared to the GSI classification system, which considers only two parameters. From the correlation, it could be indicated that there was a positive and good correlation between RMR and GSI.
