Assessment of Slope Stability and Its Remedies in Palampur, Himachal Pradesh

Alankrit Walia* and Amrit Kumar Roy

Department of Civil Engineering, National Institute of Technology Hamirpur, India

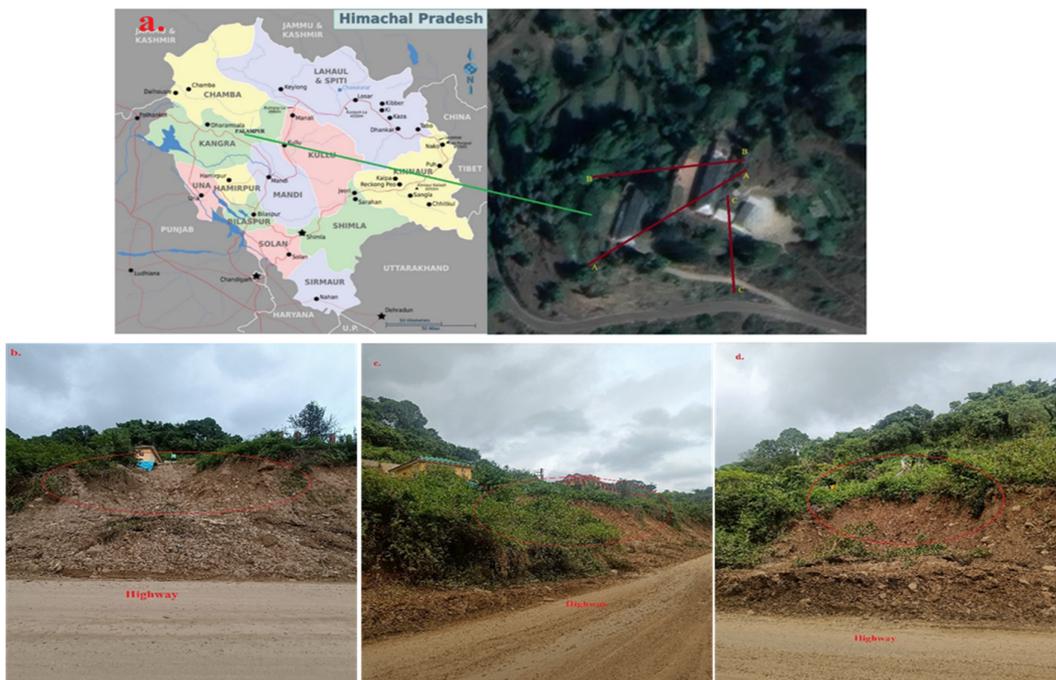
Figure 1. Location on map of studied area and site view in Palampur, Himachal Pradesh, India.

The area being investigated is in Palampur, district Kangra, Himachal Pradesh. It is at $32^{\circ}6'35''$ N latitude and $76^{\circ}32'11.91''$ E longitude. The length of the research area is 80 m and its width is 45 m. The land is 1593 m above the sea level on the southern side and 1680 m above the sea level on the northern side. There is a road on the east and south sides, a building on the west side, and a forest on the north side (Figure 1).

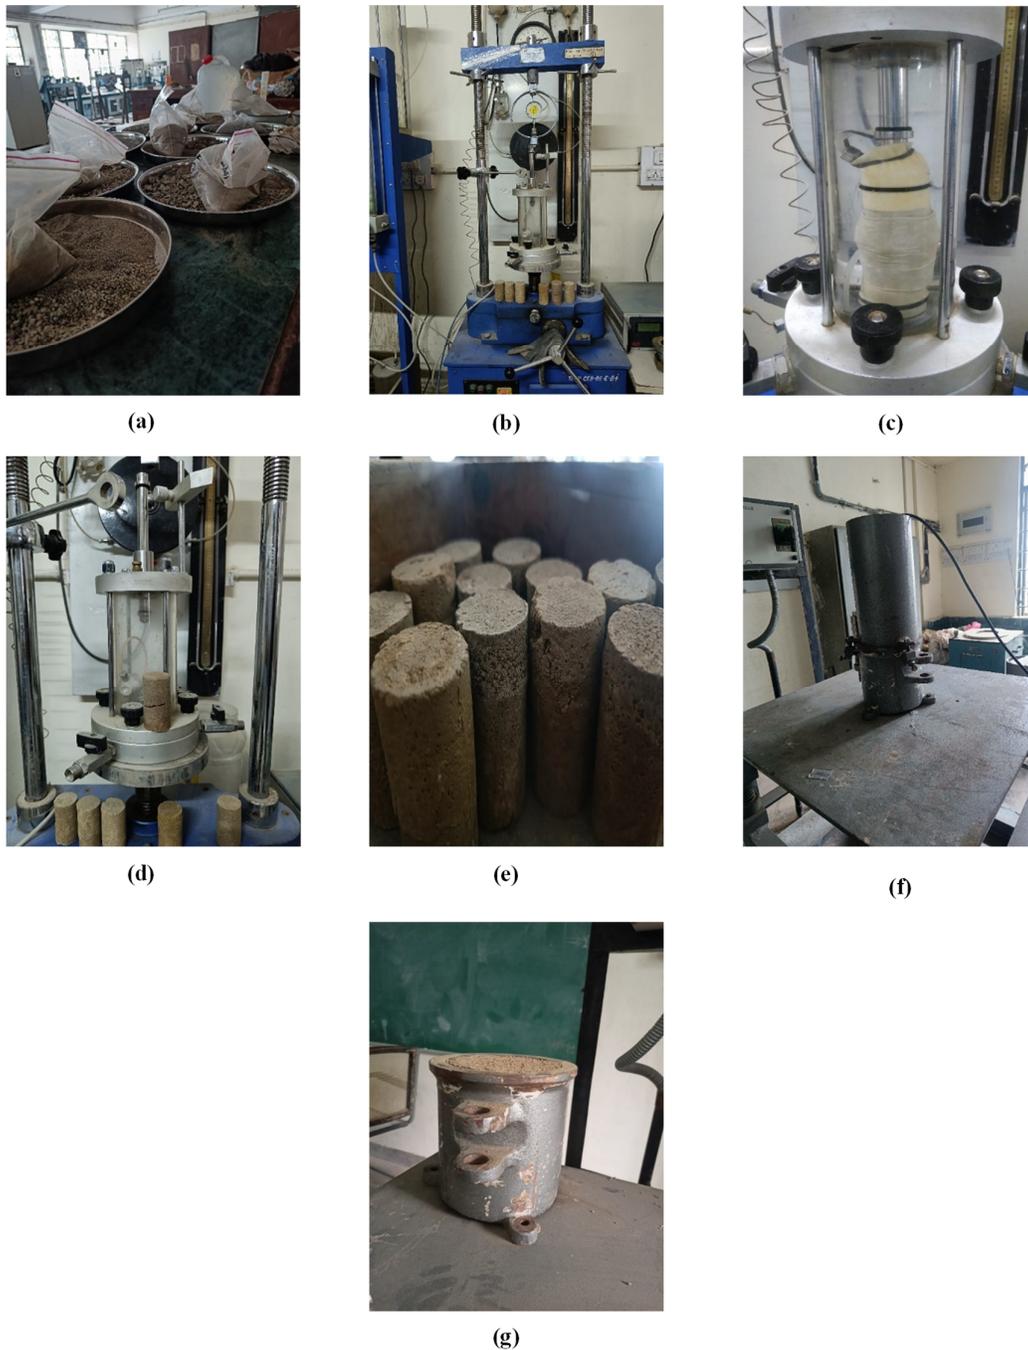
Figure 3. (a) Soil sample. (b), (c), (d) and (e) triaxial testing setup. (f) and (g) relative density test.

Through the triaxial test, the internal angle of friction (ϕ) and cohesion (c) are computed. The triaxial shear strength test examines the soil's mechanical characteristics. In this test, a soil sample is stressed such that the tension in one direction is different from the stress in the perpendicular direction. This test determines the material properties of the soil- such as shear resistance, cohesion, and dilatancy stress. The test is the most popular, and is applicable to all soil types.

The relative density test involves the assessment of the maximum dry density and the water content (humidity/density ratio) of cohesionless mixes (Figure 3).

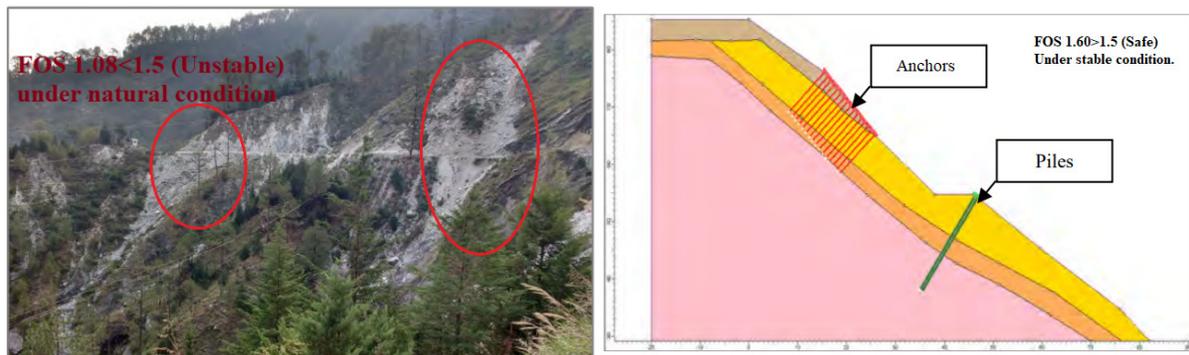
Figure 9. Natural and stable condition of studied area by [24].

The results of the stability study that were provided by [24] were evaluated alongside the results of the present slope stability analysis. This is because both studies were conducted in the lower Himalayan region, as shown in Figure 9. The researchers- [24] employed the following soil parameters in their study: cohesiveness of 12 kPa, internal friction angle of 26.5°, unit weight of 18 kN/m³, and Poisson's ratio of 0.35, respectively.

The comparison of the factor of safety (FOS) was shown in Table 8, and it corresponded to the natural situation and the stable condition after the remedies were applied. In addition, the results of the stability analysis that were reported by [25] were compared with the findings of the current study. The region of the lower Himalayas was also the location of this case study's execution. [25] Utilized the following soil parameters in their study:- cohesiveness of 15.5 kPa, internal friction angle of 32°, unit weight 25kN/m³, and Poisson's ratio of 0.20, respectively. The comparison of the factor of safety (FOS) was shown in the figure, and it corresponded to the natural situation and the stable condition after the treatments were implemented.
