Stability Analysis and Construction of Highest Gabion Wall of its own Kind in India - a Case Study

Avinash Bhardwaj*, Ajay Bhardwaj, Madhusudan Sarda and Namrata Bichewar

Gabion Technologies India Private Limited, India

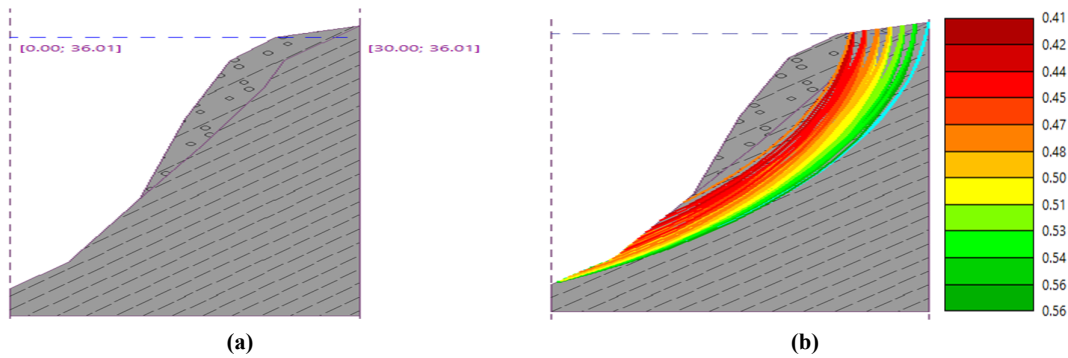
Figure 1 (a). Cross-section showing profile of slope: (b) Critical slip surfaces of respective section shown using Bishop analysis under static forces.

Figures 1 and 2 display the profile and stability analysis for the slope under consideration. From the stability analysis, it has been found that factor of safety observed using different methods is very less than minimum factor of safety value, i.e. 1.50 for both type of forces (static and pseudo-static),

and it is almost equal to zero for pseudo-static condition (Table 2). This shows that it was very important to stable the slope with a gabion retaining wall to stop the movement of the slope towards pumphouse.

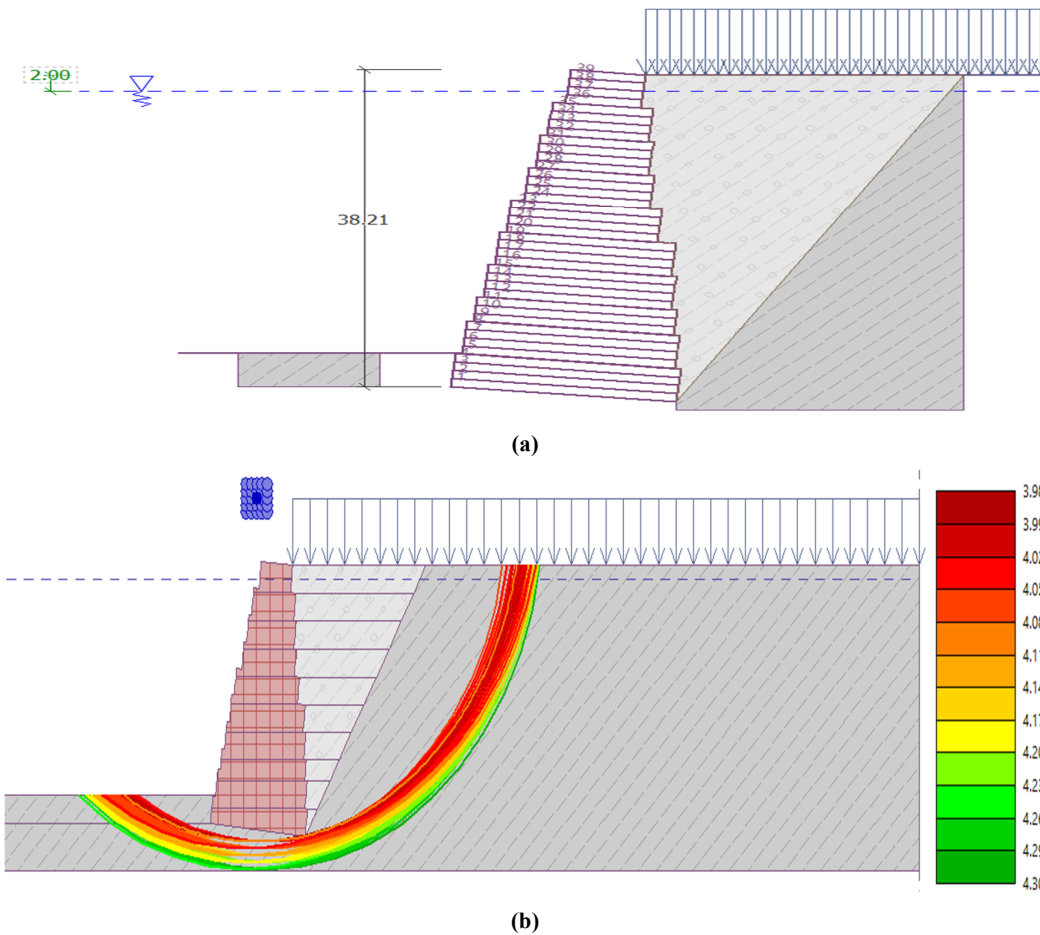
Figure 3 (a). Cross-section showing profile of slope with gabion retaining wall: (b) Critical slip surfaces for respective section shown using Bishop analysis under static forces.

The gabion wall was designed as a flexible retaining structure battered at 6° with the vertical towards the slope face. A permanent surcharge of magnitude 10 kN/m² was placed on terrain. To obtain a desired factor of safety, many analyses were performed by changing the height, width, and placement of the gabion wall. Additionally, the minimum specified values given in IS 14458 [31] were used to compare the external and internal stability of gabion walls. Table 3 presents the factor of safety values observed using different methods

for the typical section of the slope with gabion retaining wall for both static and pseudo-static forces. From the stability analysis, it has been found that factor of safety observed is very much satisfactory, and about 165% and 78% more than minimum factor of safety (1.5) for both static and pseudo-static conditions, respectively. Figures 3 and 4 display the profile and stability analysis for the slope under consideration with a gabion retaining wall battered at 6° with the vertical towards the slope face. The dimension details of

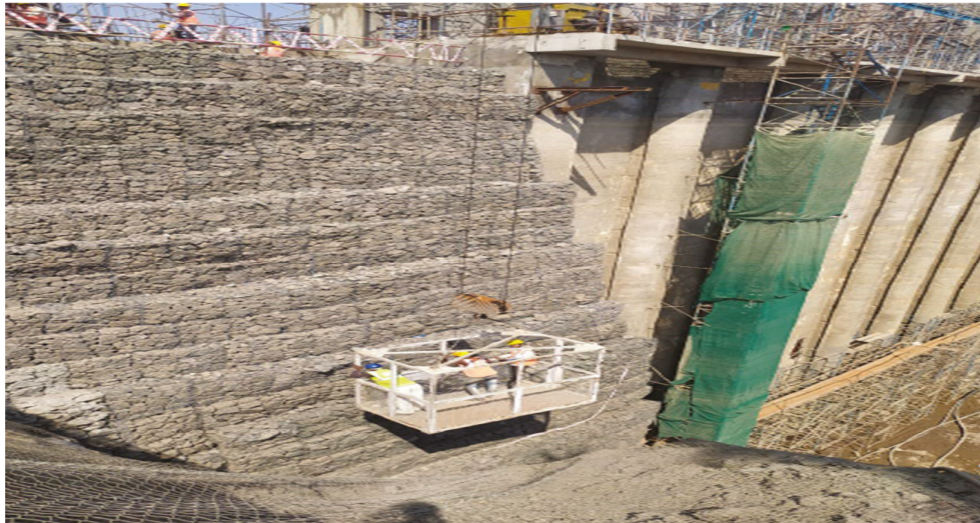
Figure 7. Mobilization of boulders using basket attached to the crane.

The construction work of the gabion retaining wall was commenced from March, 2020. For fast and efficient execution, it was recommended to use a bucket/basket attached to the cranes to reduce the time required for mobilization of boulders at 38 m depth (Figure 7). The process begins by selecting a sturdy basket made of materials like steel, equipped with attachment points or lifting hooks for connection to the crane. The basket is then securely attached to the crane's hook or lifting points with robust cables or chains. With the basket properly

rigged, the boulders are carefully loaded, ensuring they are centred and balanced to prevent instability during lifting. During lifting and transportation, constant communication between the crane operator and ground crew is vital for precise placement. After the boulders are set, the crane operator lowers the basket to the ground, and the cables or chains are detached. Mobilizing boulders using a basket attached to a crane is a reliable and effective method that minimizes the physical effort needed to move large rocks, while ensuring safety

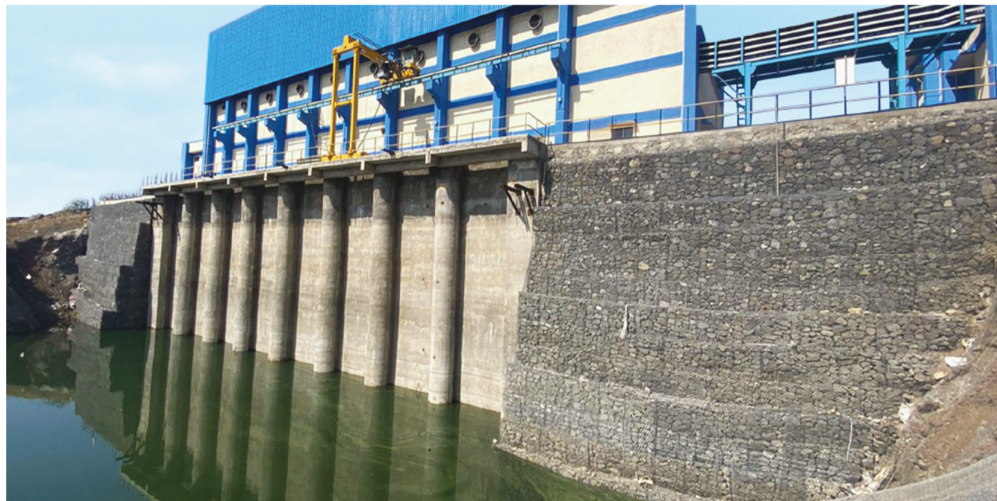
Figure 8. Gabion wall after completion submerged under backwater.

Diaphragms are positioned at intervals of 1.0 m. Gabion boxes are filled with stones that range in size from 150 mm to 300 mm, and are compressed into a 250 mm-thick layer. The backfill compaction carried out in layer of 250 mm thick to achieve 95% of MDD. Project work was huge and GTIPL team worked day and night to complete the remarkable project. This remarkable project of 38 m high gabion wall was successfully constructed by GTIPL in June, 2020 (Figure 8).

During first monsoon, 38 m high gabion wall was fully submerged under the dam's backwater for many days, and the constructed Gabion wall has been standing strong as per the field observation in October, 2023. This validates the selection and design of the control measure. Until this date, Alirajpur lift irrigation has highest gabion wall constructed. This study has collectively expanded the use of gabion retaining walls for taller structures, making them a viable solution for a wide range of applications including highway and railway embankments, coastal protection, and retaining walls in urban environments.
