Analysis of a possible root cause and mechanism for Soma mine disaster

B. Ünver* and M.S. Ünal

Department of Mining Engineering, Hacettepe University, Ankara, Turkey

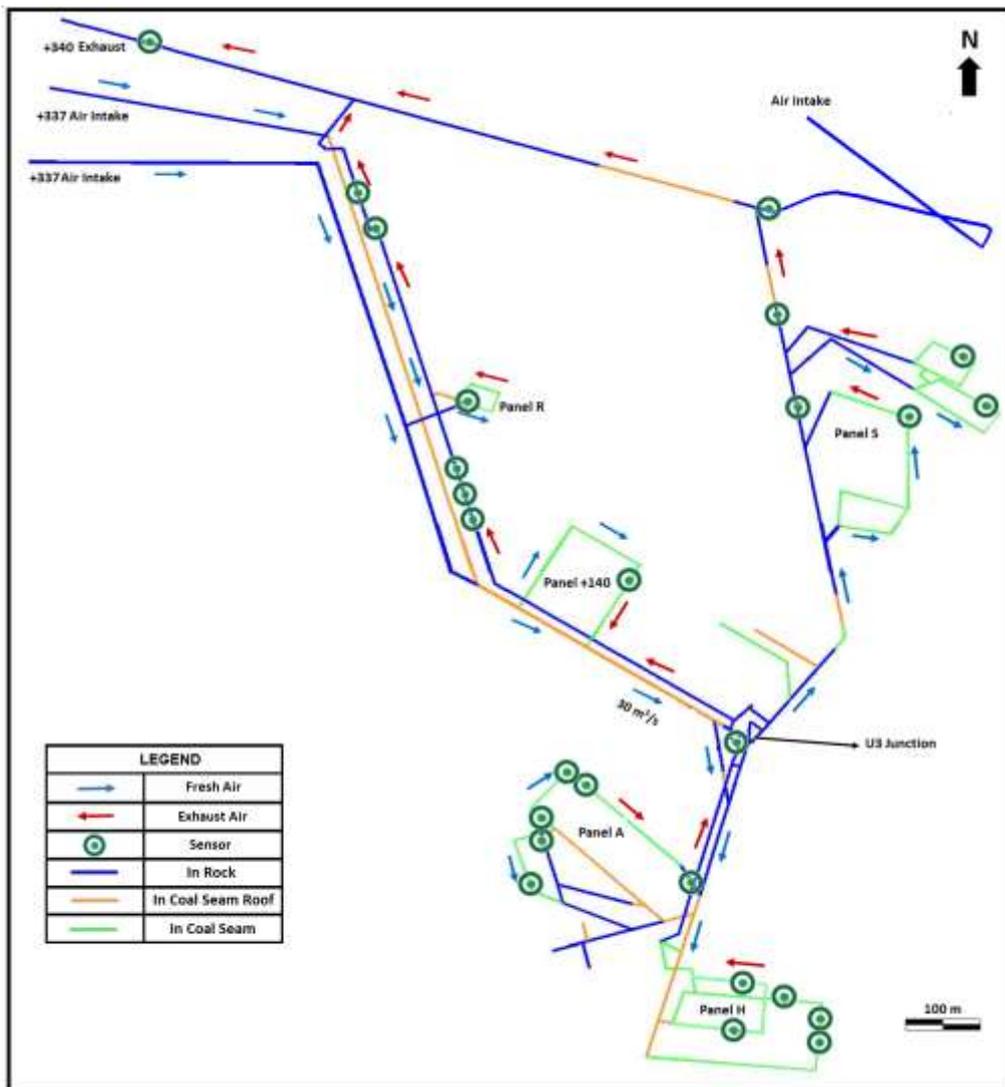
Figure 5. Eynez Karanlıkdere underground mine plan showing locations of operating panels, sensor locations, and ventilation (modified from [8]).

Altogether, there were 9 operating longwall faces in the mine at the time of disaster. Worked out panels such as B, C, D, and M, which had a critical role in the mechanism of disaster, can also be seen in Figures 5 and 6.

Sensors were mounted at critical locations of the mine and faces as they could continuously measure the harmful gases inside the mine. There was an underground mine monitoring control room at the surface. There were 27 monitoring stations equipped with 48 independently working fixed sensors. Figure 5 presents the locations of monitoring stations. 19 of these sensors measure methane, 19 of them measure carbon monoxide, 9 measure oxygen, and 1 of them measure carbon dioxide. In addition, there are one pressure and one temperature sensor mounted at the exit of the main return airway.

There were 27 monitoring stations having a total number 19 CH₄ and again 19 CO sensors (Figure 5). There were 9 oxygen and 1 CO₂ sensors in the mine. All of the engineers and technicians were known to carry portable gas measuring equipment capable of measuring CO, CH₄, O₂, CO₂, and temperature. The measured data from portable equipment was decoded and present at the court;

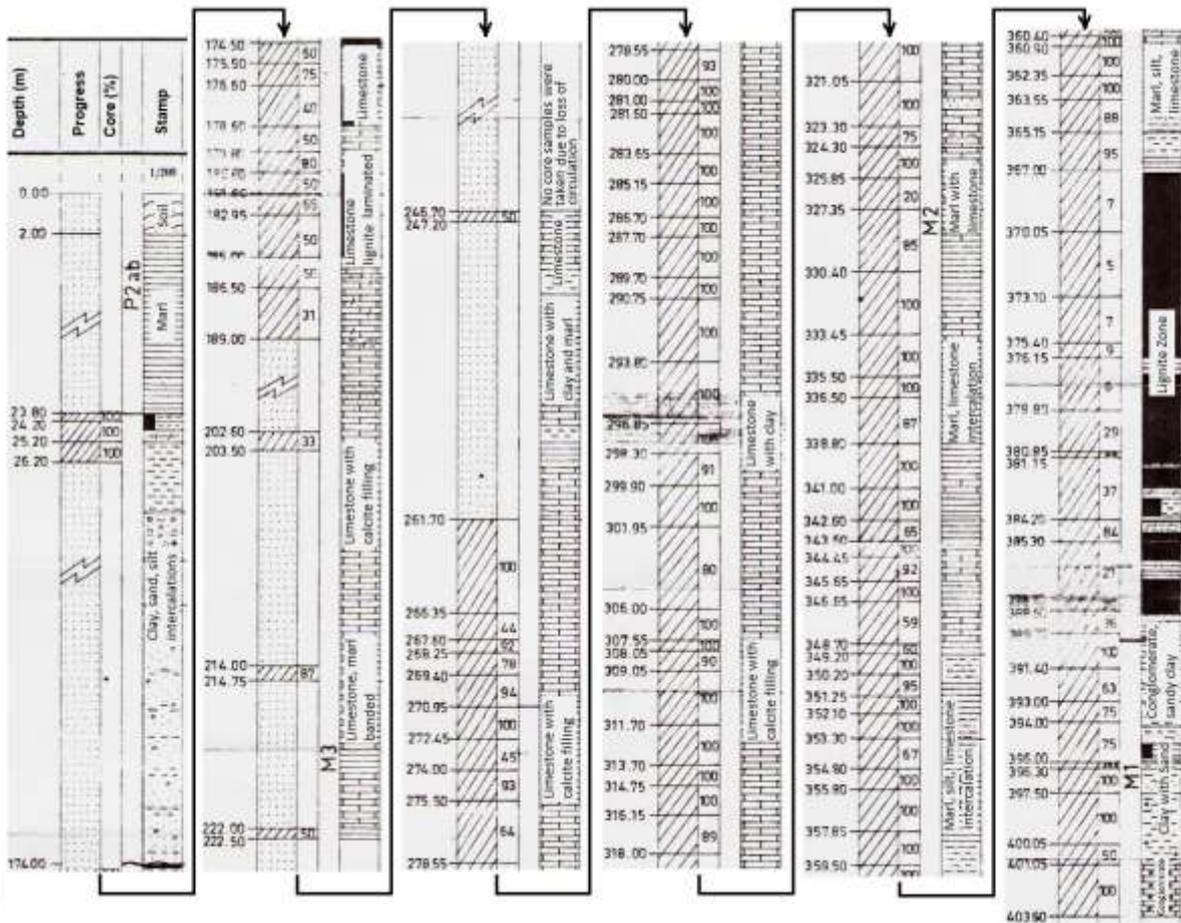
Figure 11. Log of the surface exploration borehole E72 opened on panel C.

limestone strata is known to have natural dissolving caves. It is frequent at the Eynez field not to have circulation during exploration drilling, especially at the limestone layer. Such a zone has also been seen in the surface exploration borehole log presented in Figure 11. Although a 25-m thick coal seam was produced, the maximum amount of subsidence was said to be not more than 8 m. Therefore, it is obvious that judging by the

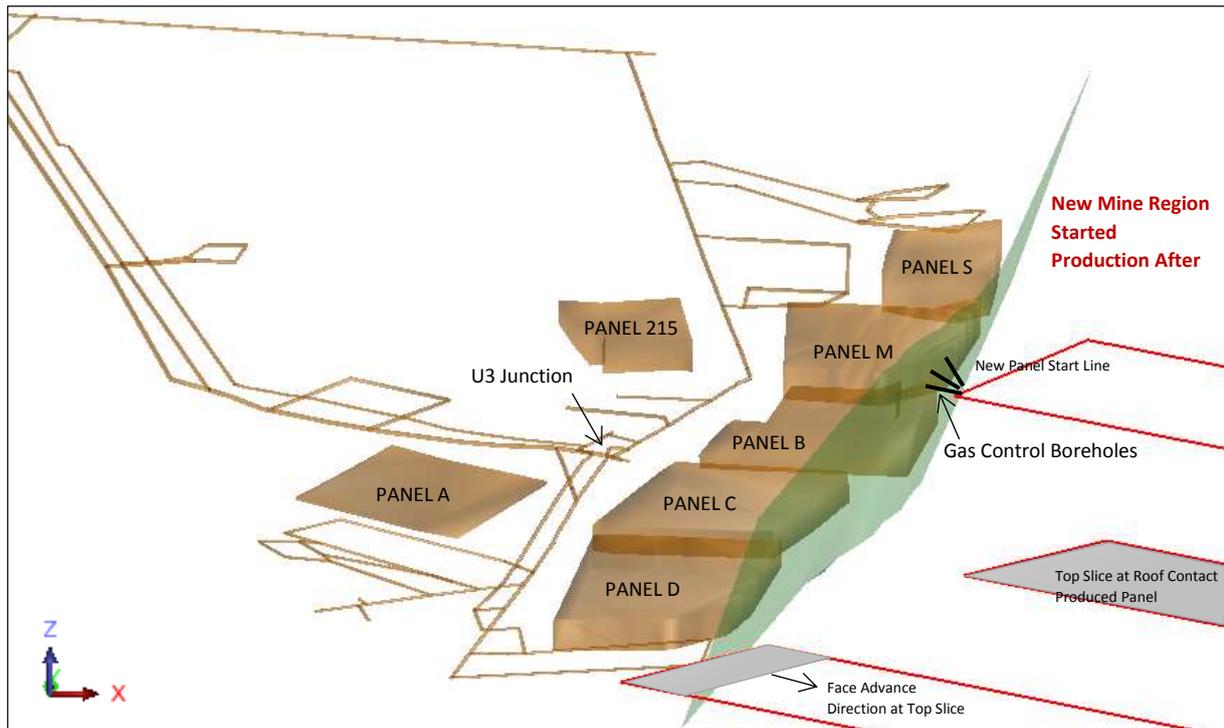
Figure 15. Location of Karanlıkdere mine and panels of the new adjacent mine.

Production was started at the adjacent mine in February 2015. Top slice production has been completed at the panel located in the middle, as shown in Figure 15. During development of the nearest panel to the old workings of Karanlıkdere mine, gas control boreholes were drilled, as seen in Figure 16.

As shown in Table 3, after drilling 24, 15, and 12 m, concentrations of CH₄ and CO₂ were found to be above the detection limits. Unfortunately, it was not possible to learn the exact gas concentrations. This can be considered as an indication of gas accumulation in the caved regions of the old workings of Karanlıkdere mine. It is probable that the caved regions of Karanlıkdere mine have been interconnected due to caving during production of the middle panel at the new adjacent mine. This might have resulted in the escape of some CH₄ to the surface through newly-formed subsidence cracks. It is also possible that a connection between these two mines might have been created, forming an air passage way between these mines. It is suggested that these phenomenon should be further investigated. It is also suggested to open methane drainage surface boreholes, especially above panel D and panel H of Karanlıkdere mine before commencing the production activity at the mine.
