## Cut Out Distance – A Critical Parameter for Mechanized Depillaring by Continuous Miner

Manthri Rakesh\*, Ashish Kumar Dash, and Sunny Murmu

Department of Mining Engineering, National Institute of Technology Raipur, Raipur, India

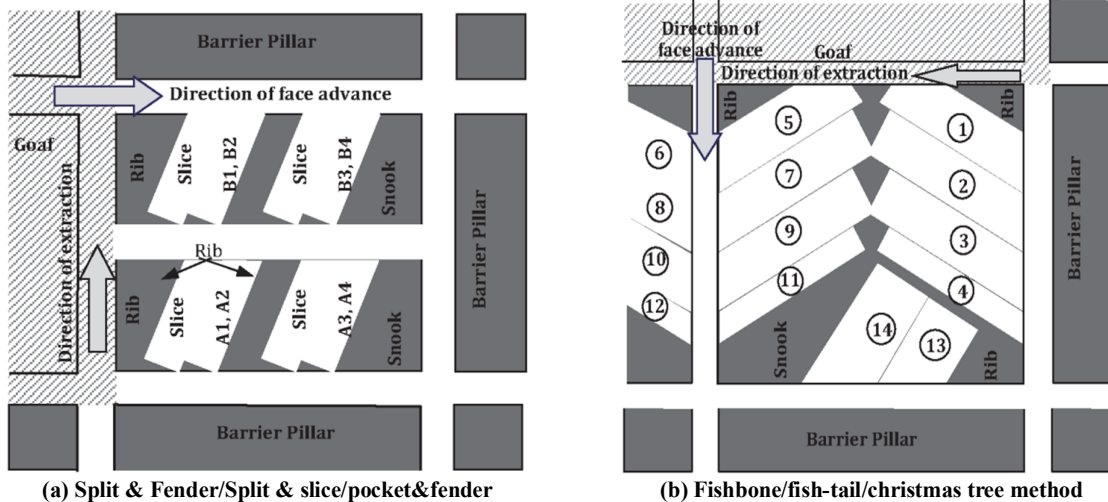
**Figure 1. Pillar Extraction Methods in Indian mechanized depillaring panels using CM**

(a) Split & Fender/Split & slice/pocket&fender

(b) Fishbone/fish-tail/christmas tree method

There are two methods of extracting pillars in Indian Mechanized Depillaring (MD) panels: Fishbone/Fish-tail/christmas tree and split and fender/split and slice/pocket and fender as shown in Figure 1. The fishbone/fish-tail/christmas tree method is used for smaller pillars, while the split and fender/split and slice/pocket and fender method is used for larger pillars, according to regulation 111 of the coal mines regulations (2017) [9].

The cut-out distance may vary depending on the depillaring method. Mechanized depillaring by continuous miners mainly includes two types, i.e., split and fender method & fish bone method; COD can be high during depillaring by the split and fender method as this method is adopted for large size pillars. COD can be low in the fishbone method as compared with the split and fender method because it is adopted for smaller size pillars.

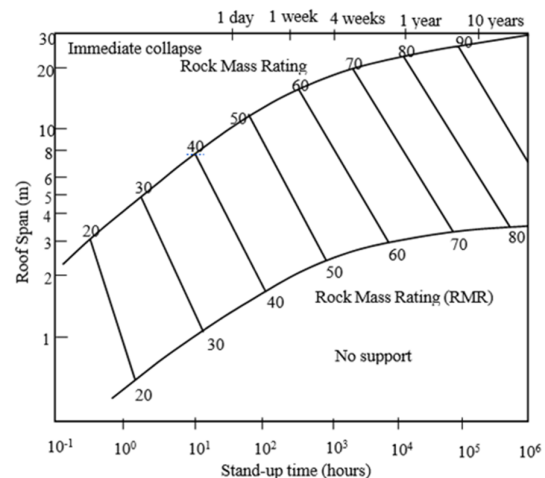
Figure 3. Stand-up time and unsupported span based on RMR and joint factor

Author [17] used the Rock Mass Rating (RMR) developed by [18] for stand-up time and unsupported span of roof and plotted a relationship to estimate COD for a tunnel that has a single opening (as shown in Figure 3). [19] Introduced the Coal Mine Roof Rating (CMRR) to evaluate the lithological factors affecting the structural stability of mine roofs in U.S. coal seams. Using the CMRR values, [20] predicted safe Cut-Out Distances (COD) for coal mines in the U.S.

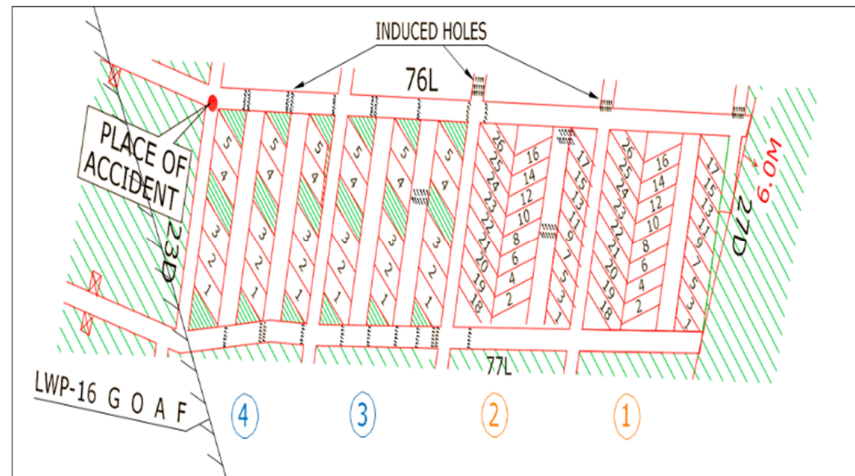
Figure 6. Plan showing location of incident

worked on. Suddenly, a 3 m stone layer collapsed at the junction, trapping six miners, the CM, and a shuttle car. Two miners survived with serious

injuries, while four sustained fatal injuries. Rescue operations recovered the victims and machinery. The incident location is shown in Figure 6.

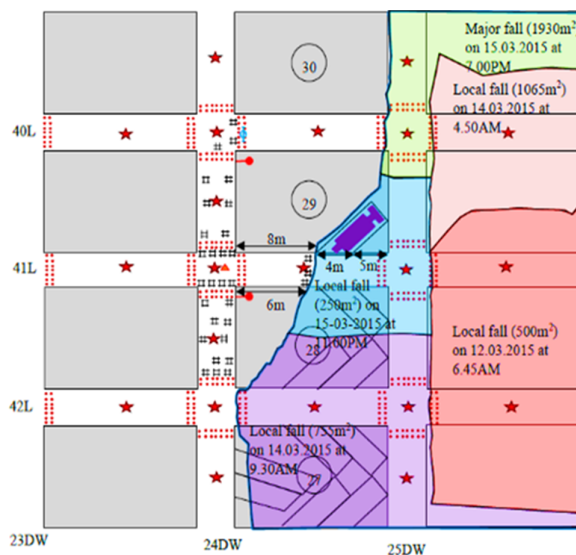
Figure 10. Plan showing location of incident 2

Incident:2 During the first slice extraction of the pillar, the CM was buried due to a roof fall that resulted in an electrical fault, leaving it inoperable under unsupported strata surrounded by discontinuities. Attempts to retrieve the CM with a ram car failed, but it was successfully pulled out using a puller and temporary supports. Tell-tale readings showed roof dilation exceeding the permissible limit of 10 mm, leading to personnel withdrawal. Strata monitoring instruments recorded 0.136 MPa stress, ruling out dynamic loading as the cause. No caving or rib spalling occurred; only 400 m<sup>2</sup> of hanging area was noted in the goaf. By these observations, the roof fall was attributed to delayed extraction, unsupported strata, and local geology. The Incident location is shown in Figure 10.

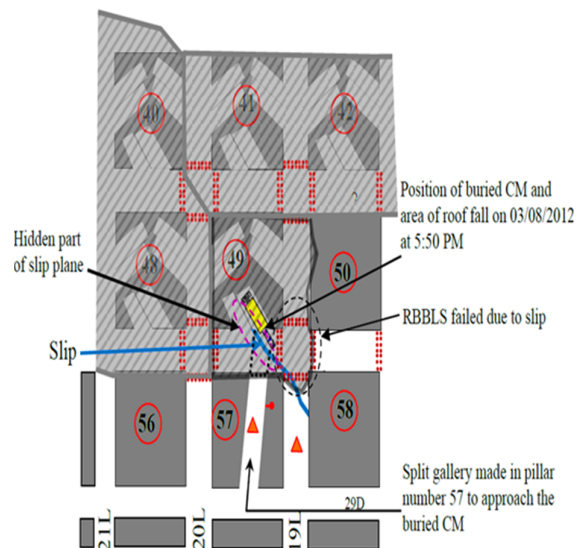
Figure 9. Plan showing location of incident 1

Incident :1: In mine B, the fishbone/christmas tree method was used for depillaring. During the second push-out of pillar 49, all of a sudden, a 4–5 m thick roof fall buried the CM, cutting its power supply. Successive roof falls followed, completely burying the CM. The roof near the extraction stage was disturbed by geological discontinuities, but strata monitoring instruments showed no signs of stress or dilation. Visual inspection revealed the final roof height was around 20 m. The fallen roof rock was cleared, the CM was recovered using a puller and arch support, and the CM was operational after power restoration. The exposed snooks near the burial site were intact, and the hidden slip in the area was identified as the cause of the roof fall. The roof fall location is shown in Figure 9.

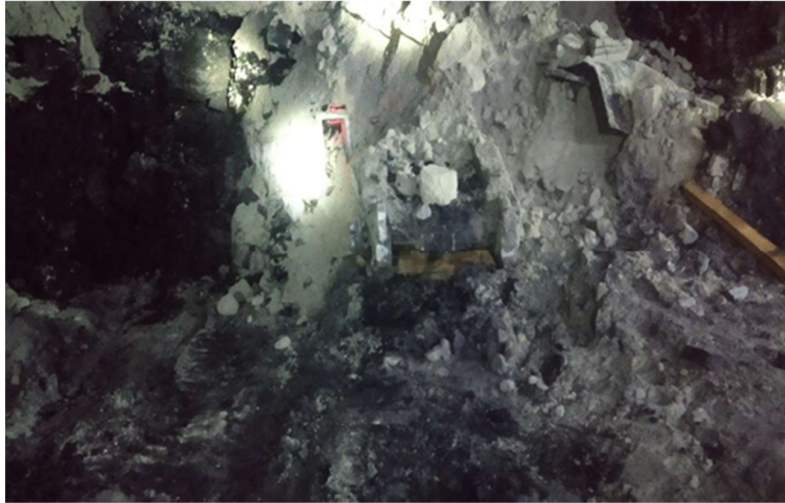
**Figure 11. Burial of CM due to roof fall**

Incident 1 mine C, opened on 1st May 1992, operates at a depth of 28-125 m with shale and shaly sandstone as the roof and floor. The gallery size is 6.0 m x 3.5 m, and pillar sizes are 25 m x 25 m, 25 m x 20 m, and 20 m x 20 m. Continuous Miner (CM) technology was introduced on 10th May 2017. The CM was buried in panel 2 at Location 25LE/47D. It was retrieved on 28th February using pullers, bolts, and wire mesh. The first main fall area was 5625 m<sup>2</sup>, with the hanging roof area before burial at 625 m<sup>2</sup> and 0 m<sup>2</sup> after the fall. During slice 5B extraction, a local layer fell on the CM, causing the main fall and burying the machine. The photograph of the CM Burial is shown in Figure 11.

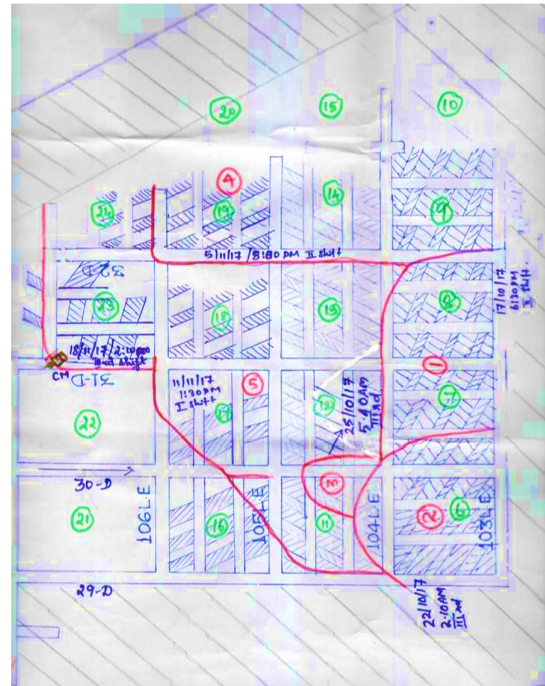
Figure 13. Plan showing location of incident 3

Sounds in the goaf indicated a fall to be occurred, and roof fall occurred as the snook was extracted to 5m. While sweeping loose coal, half the body of the CM was trapped by a roof fall, with about 450 m<sup>2</sup> of debris covering the CM. A puller was used to retrieve the CM, but three heavy-duty rope slings broke. Blasting was done to remove the load, and the puller successfully moved the CM 1.5m, eventually retrieving it. The place of the incident is shown in Figure 13.

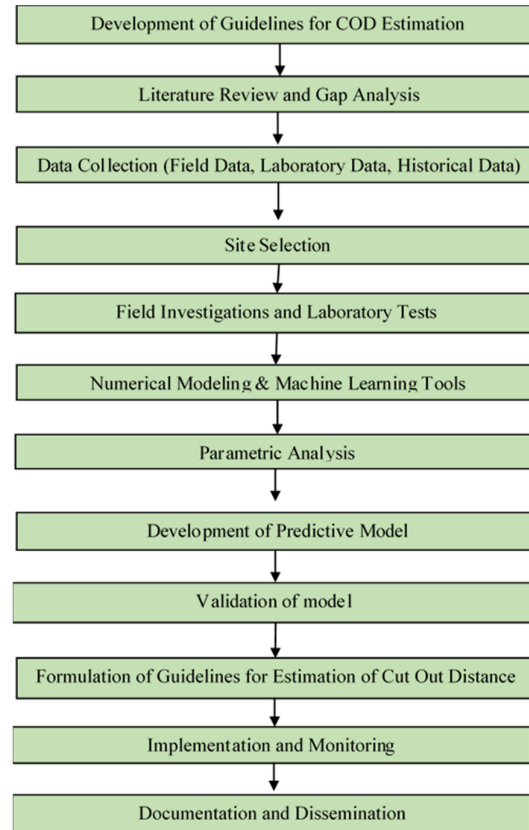
**Figure 14. Proposed flow chart of methodology for development of guidelines for COD estimation**

and develop user-friendly predictive models that mining engineers can apply without extensive computational expertise. A flow chart of methodology for the development of guidelines for estimation of COD is suggested for future research.
