# Engineering Challenges and Remedial Measures in Black Cotton Soil Dump Adjacent to Hamlet: A Case Study from Opencast Mine

Rahul Shende, Omkar Navagire, Himanshu Kumar Jangir, Srinivasan Venkatraman\*, Anirban Mandal and Anjan Patel

Visvesvaraya National Institute of Technology, Nagpur 440010, Maharashtra, India

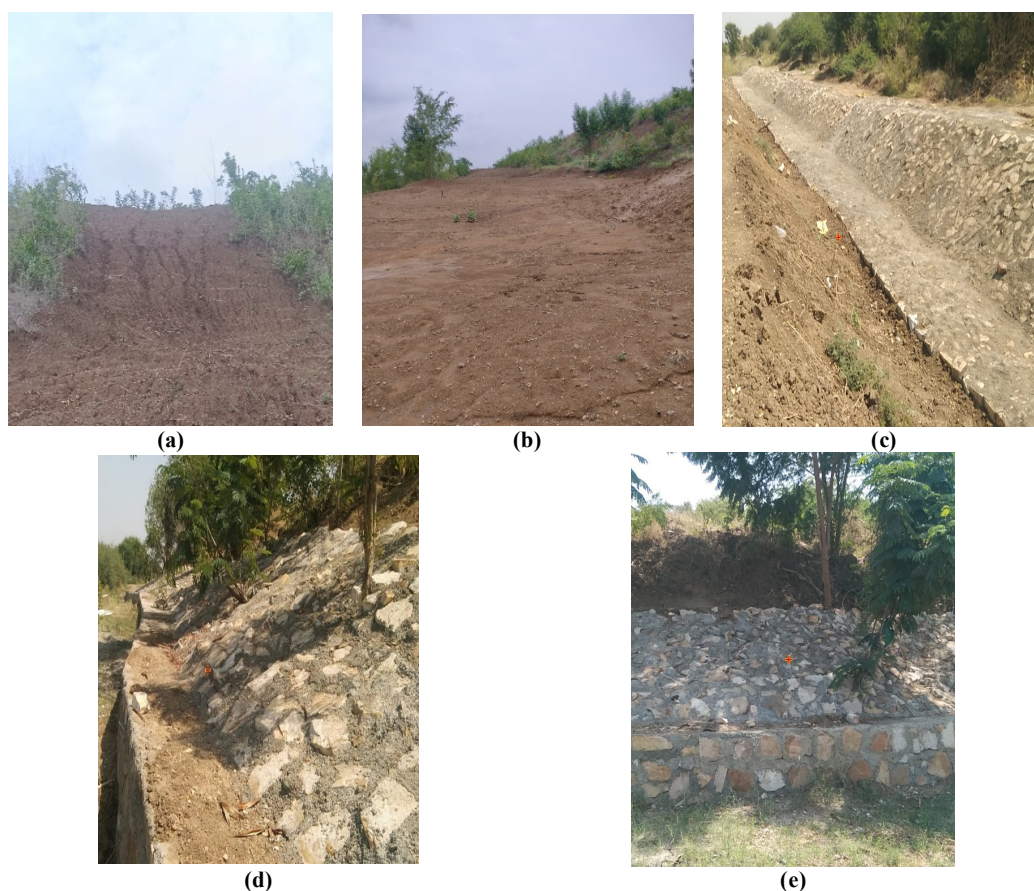
Figure 10. Implemented remedial measures at the site

As per the recommended remedial measures, the onsite application of the measures was implemented. The following remedial measures have been implemented at the site:
